AFRL-RX-TY-TR-2009-4608

SMOOTHNESS EVALUATION OF EXPEDIENT REPAIRS AT AVON PARK

TONY GERARDI

NOVEMBER 2009

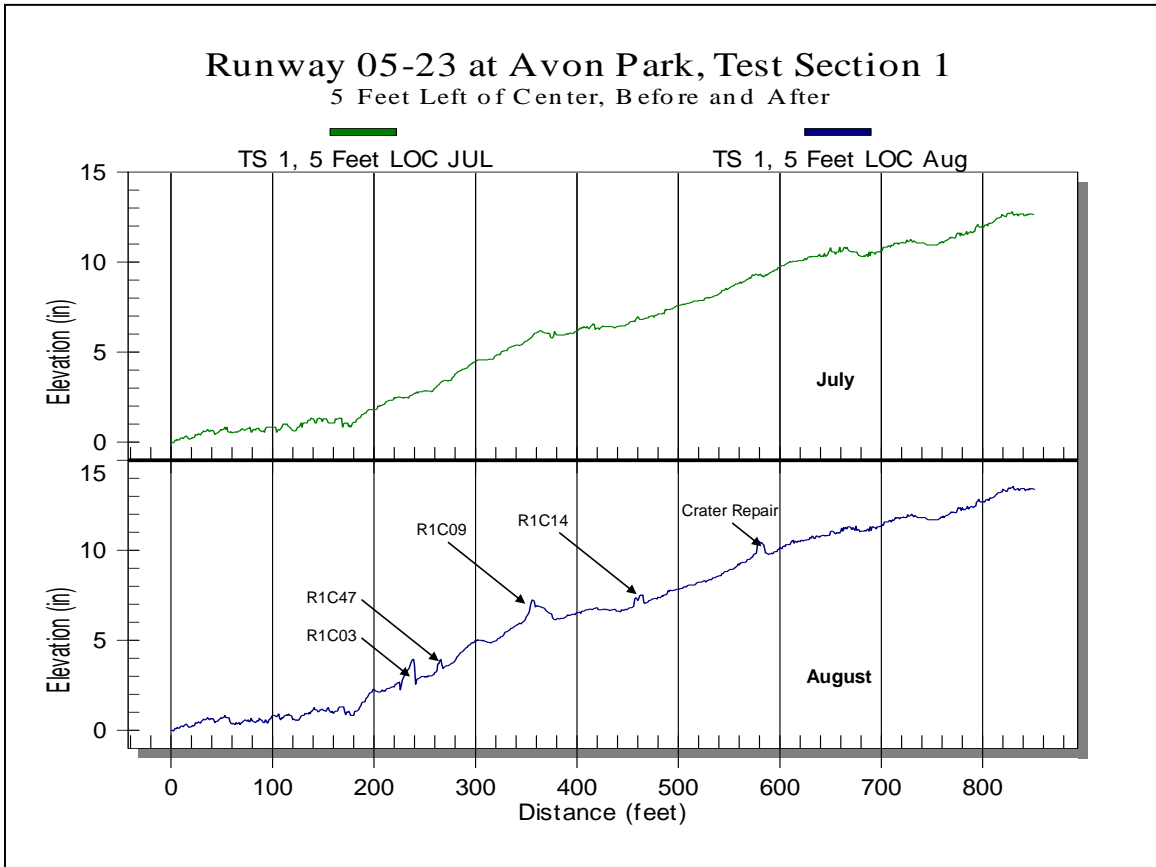
Figure A-1: Profile Plots of Test Section 1 on Runway 5-23, 5 Feet Left of Center Before and After

All analysis figures are contained in the appendix. Figure A-1 is a plot of the centerline of the entire runway from threshold to threshold. It shows the full length profile measured in July and in September. Each of the 13 test section lines of survey are plotted with the before and after expedient repairs. The profile plots are followed by 16-foot and 100-foot straightedge plots of the before and after expedient repairs. Figures A-2 through A-45 are the results for test section one. Figures A-46 through A-65 are the results for test section two. The crater repair identifications that were visible during the survey, which are shown on the plots, are also contained in the data files emailed to the AF point of contact (POC).

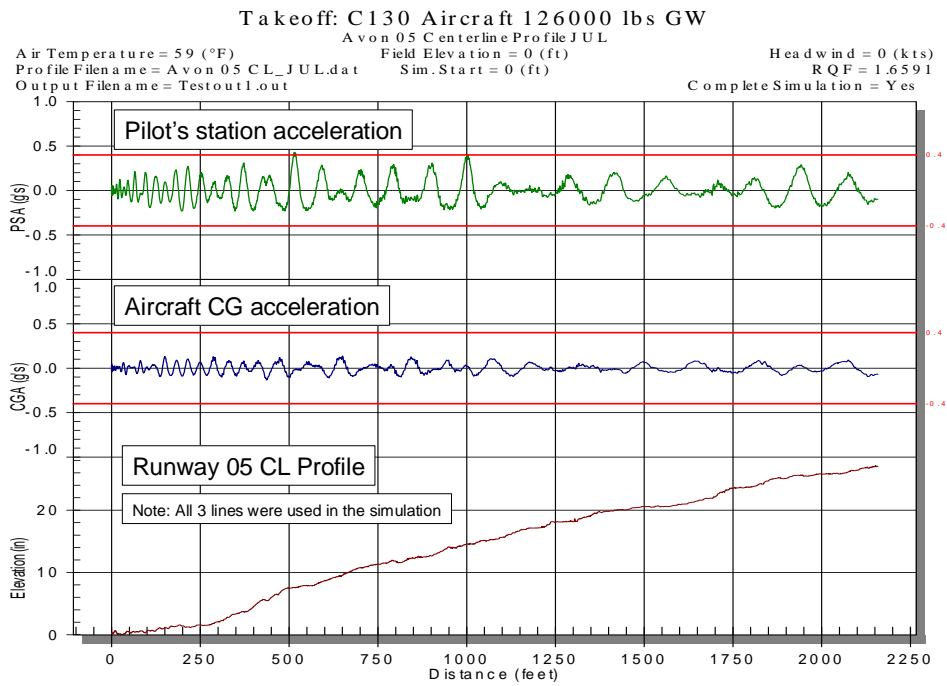
Figure A-66: C-130 Takeoff on Avon Runway 05 Before Damage

Figure 68 is a C-130 takeoff on the undamaged Runway 05 profiles. The plotted result is typical for C-130 operations on an aging commercial runway. Full length profiles were simulated for the centerline (CL) and 5 feet left and right of the CL before the crater exercise. Figure 69 is a C-130 takeoff on the same runway after the expedient repairs were made. The takeoff simulation produced moderate aircraft response which was a surprising result. The term moderate is based on the g-level experienced at the cockpit pilot station (PS) and/or the aircraft center of gravity (CG). Moderate, as defined by APR's experience, is multiple events where the acceleration is above .6 g. The C-130 is very capable of rough field operations; consequently, little response was expected on the repaired Avon Park runway. However, the moderate accelerations produced at the cockpit indicate that a resonant loading condition was occurring. This was caused by the fact that multiple repairs were involved. Just as the aircraft was rebounding from one bump, another was encountered. It should be noted that the moderate response predicted for C-130 is not enough to prevent operations, but could reduce aircraft fatigue life and increase operational maintenance.

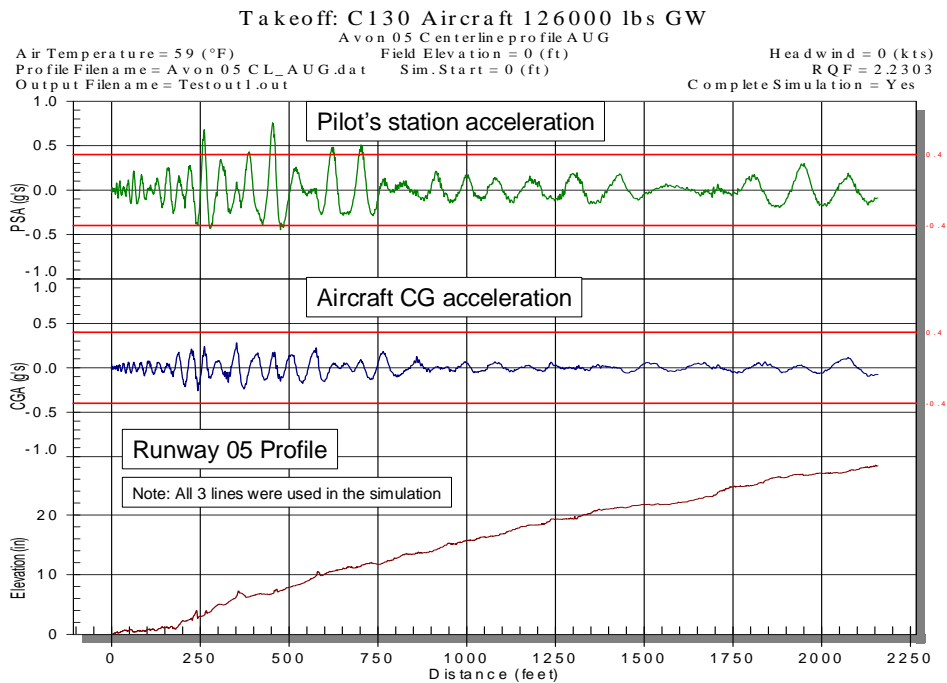
Figure A-67: C-130 Takeoff on Avon Runway 05 After Expedient Repairs

The repairs were encountered at a speed that was tuned to the natural frequency of the C-130. The speed that section 1 was encountered began at 30 knots and ended at 43 knots. Had the section 1 repairs been located on another section of the runway, they would not have caused a moderate response. Figure A-68 shows that the response is acceptable if the threshold is displaced just 500 feet.

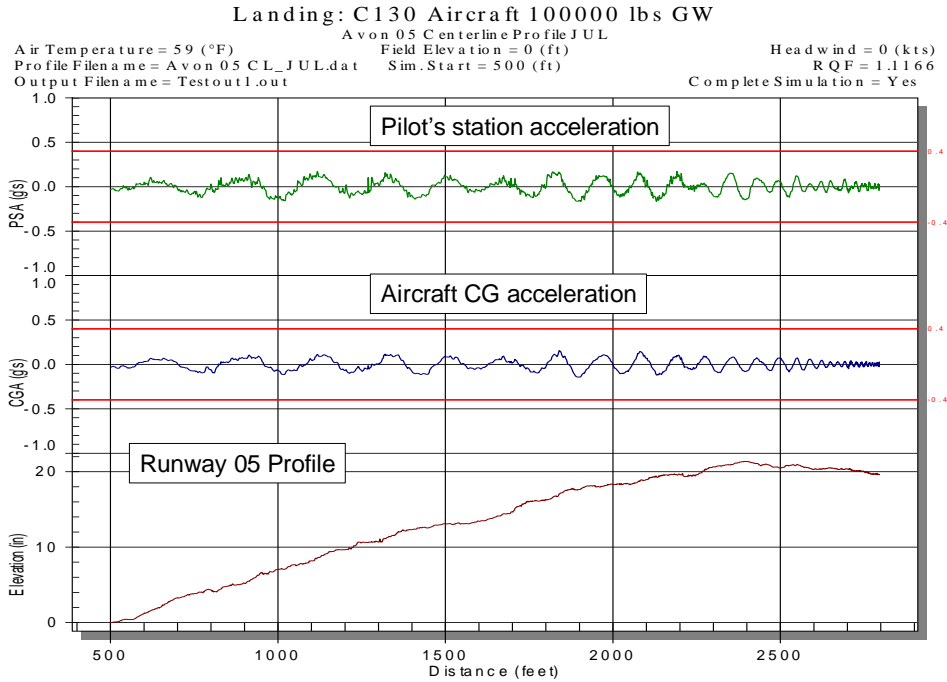
Figure A-72: C-130 Landing on Avon Runway 05 Before Damage

Several landing simulations were also conducted. Figures A-72 through A-75 show that the repairs had very little impact on the F-16 or C-130 response.
